## **Thermal Imaging of Canals for Remote Detection of Leaks: Evaluation in the United Irrigation District**

**Texas Water Resources Institute Technical Report  
November 2008**

Yanbo Huang and Guy Fipps, P.E.<sup>2</sup>

December 20, 2002

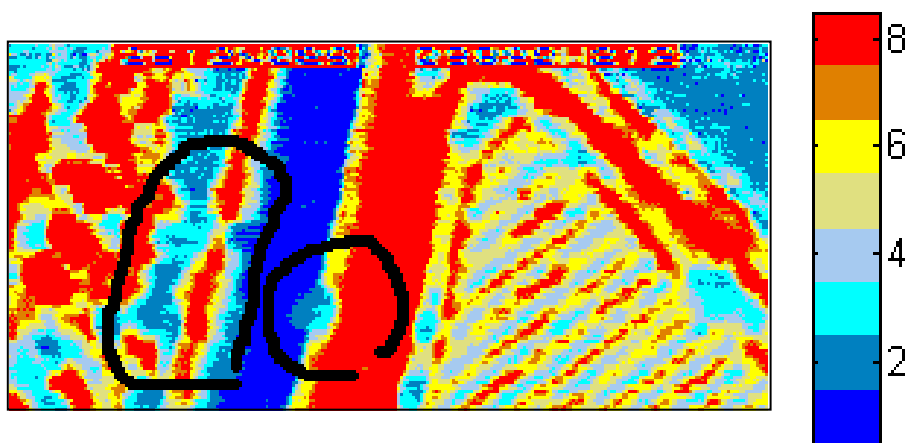
As seen in figure 2a, on one side of the canal (right side on the image) there is a wide strip which is likely a dirt road on the canal levee. On the same side beside the canal, an area showing the possibility of wetness or vegetation (mark circled on the right of the image). On the other side of the canal (left side on the image), there is another area of vegetation and/or wetness and a narrow dirt road (mark circled on the left of the image).

Figure 2a. Site 1 - Original processed image.

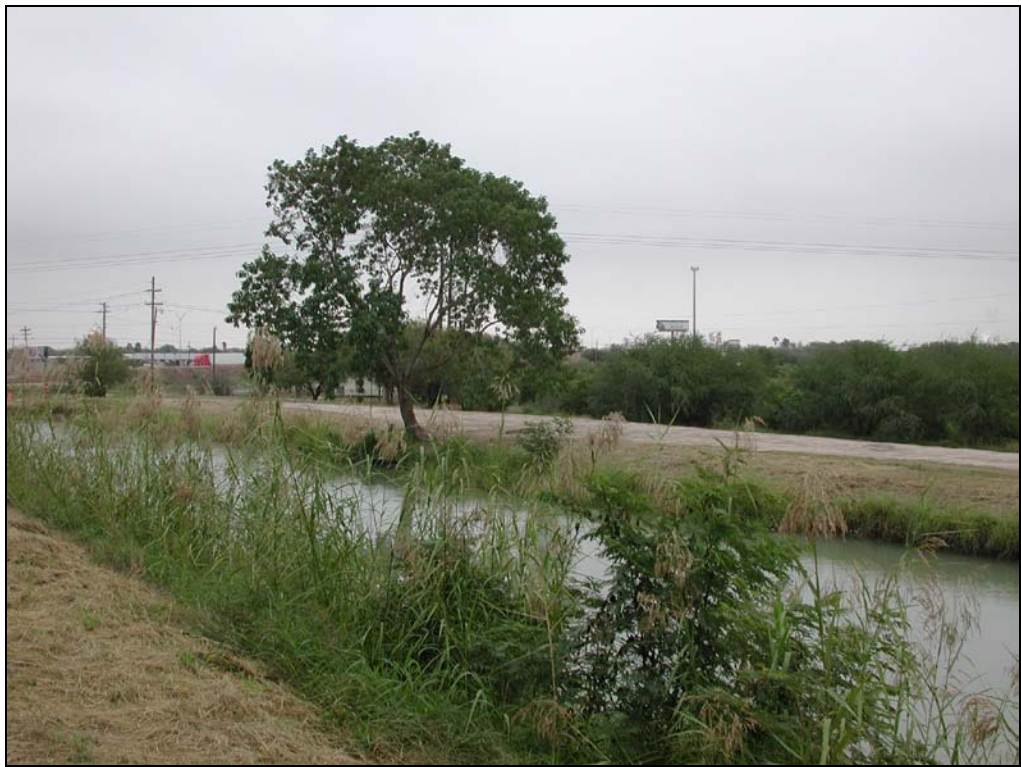
- Wetness: 2
- Vegetation:
  - Grass – 2
  - Trees – 2
  - Crops – 0
- Seepage: 2
- Cracks: 0
- Holes: 2

Photographs taken at this location show a large tree and the dirt road on the same side of the canal (Figure 2c). Water appears to be flowing out of the canal through a large hole located near the tree. Figure 2d shows thick vegetation (grasses and bushes) with a narrow stripe of dirt road. The site evaluation matched very well our interpretation of the thermal imagery.

***Conclusion: this canal segment has a severe seepage problem at this location caused by a hole in the canal.***

Figure 2c. Photograph of Site 1 – an unlined canal segment with a hole in the embankment.

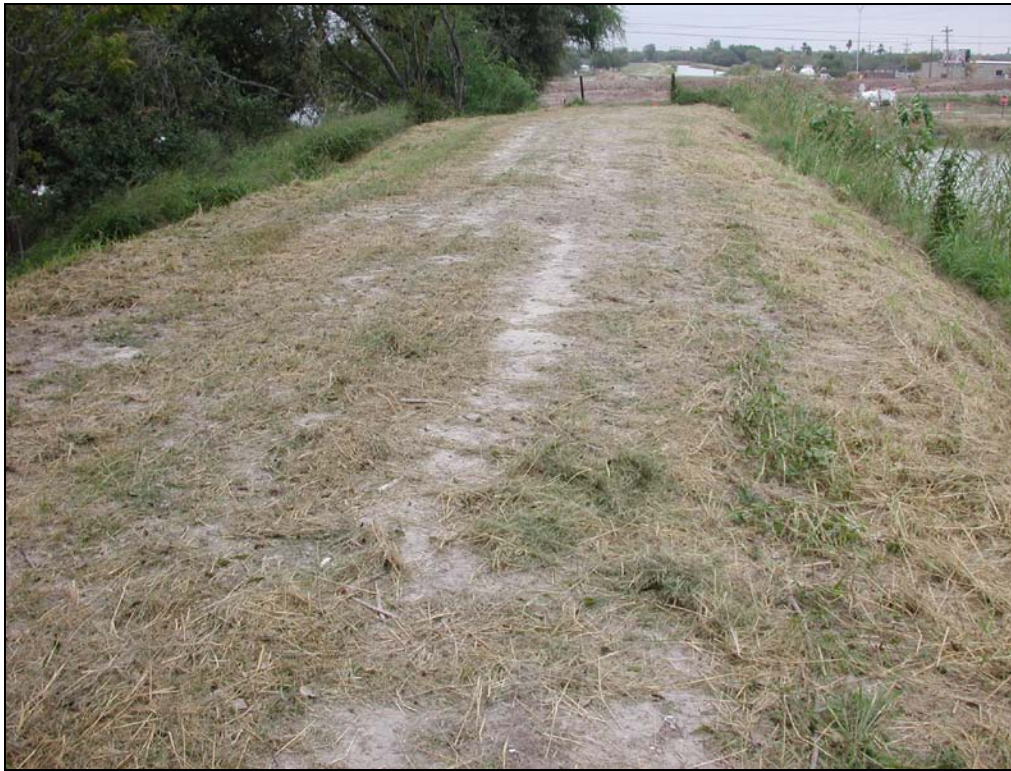
Figure 2d. Photograph showing dirt road on canal embankment at Site 1.

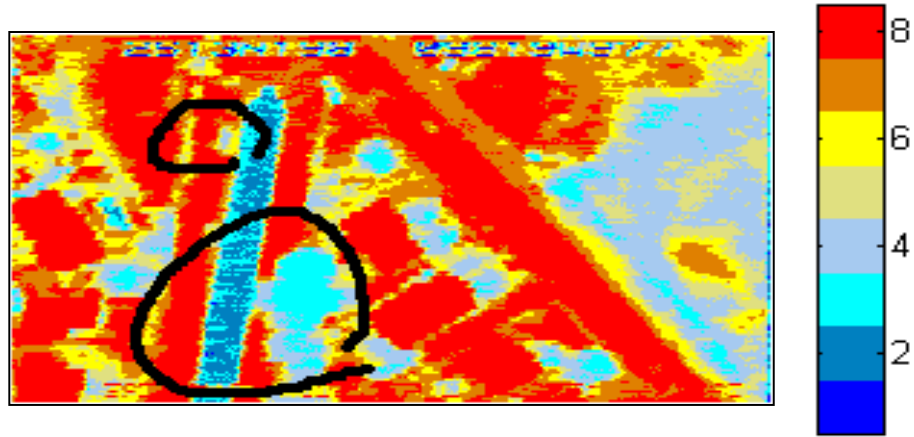
As shown in Figure 3a, the thermal image shows two areas of wetness (mark circled on the image) on either side of the canal. Figure 3b shows the inverted image overlaid onto the DOQQ (Figure 3b). The results of the field evaluation are as follows:

Figure 3a. Site 2 - Original processed image.

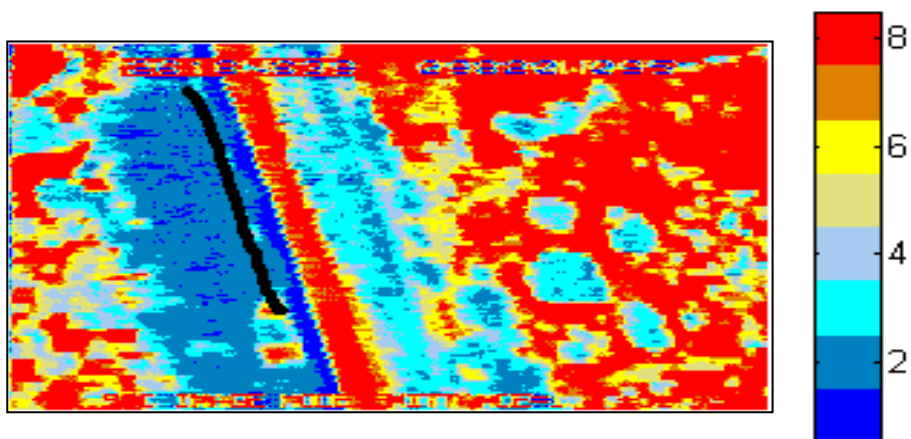
As shown in figure 4a, there is likely a seepage area along one side of the canal (left side on the image). The rating of this site is as follows:

Figure 4a. Site 3 - Original processed image.

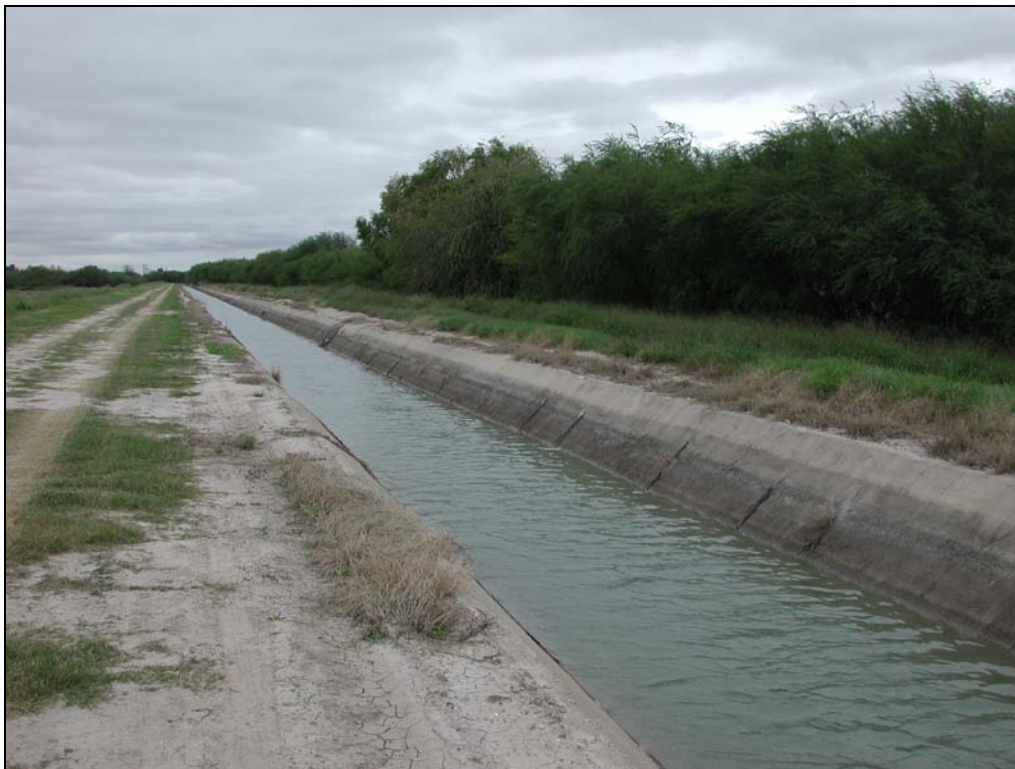
The field photograph (Fig. 4c) shows thick vegetation on the side of the canal having and many cracks. Some of the cracks are sealed but others are not. These unsealed cracks appear to be the cause of the seepage from this canal segment.

***Conclusion: thermal imaging detected seepage caused by cracks in a canal.***

Figure 4c. Site 3 – showing cracks and thick vegetation on one side of the canal.

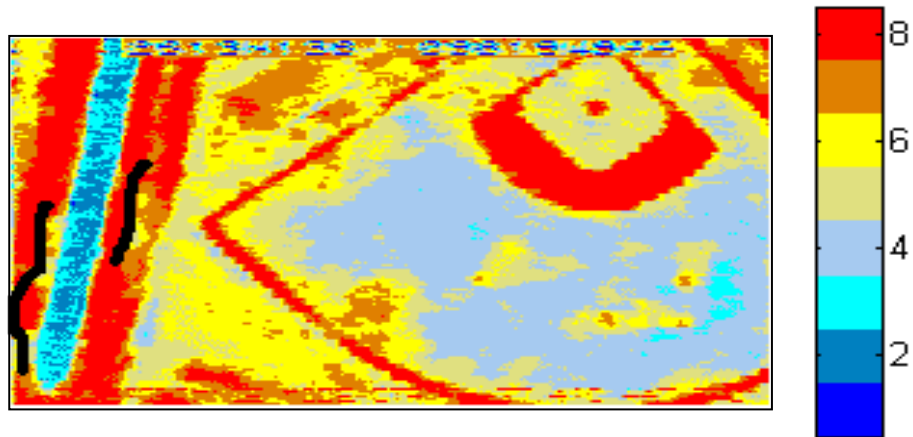
Figure 5a shows a canal segment beside a baseball field. While there is no indication of vegetation or wet areas along this segment, there is something other than a dirt road (line-marked on the image). This image was inverted and overlaid on the DOQQ image (Fig. 5b). The rating results are as follows:

Figure 5a. Site 4 - Original processed image.

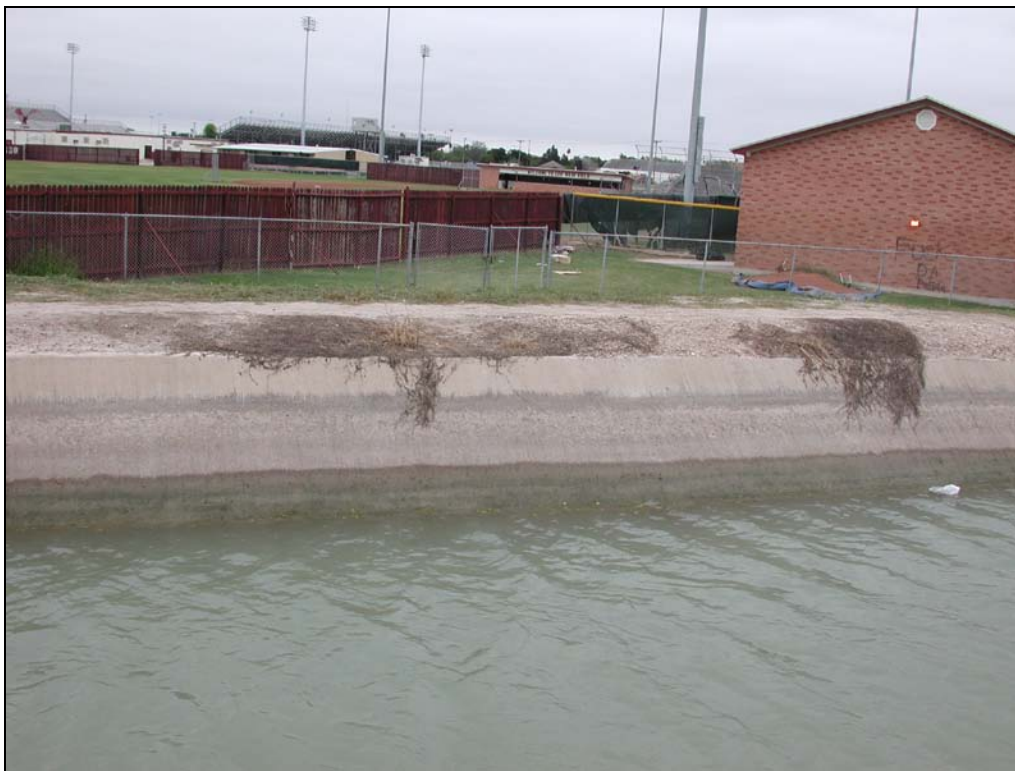
The photograph (Fig. 5c) shows some dead vegetations spread over the sides of the canal, but otherwise the conditions of the canal is good. This canal segment does not have a detectable leak.

*Conclusion: this canal segment is unlikely to have a leak.*

Figure 5c. Site 4 – Photograph showing the dead grass along the canal and that the canal segment is in good condition
